## **Forensic Evaluation of Video Footage from the TIGHAR 2010 and 2012 Nikumaroro Expedition- Supplemental Report**

By: John D. Jarrell, PhD, PE

**February 28, 2014**

### **Supplemental Report**

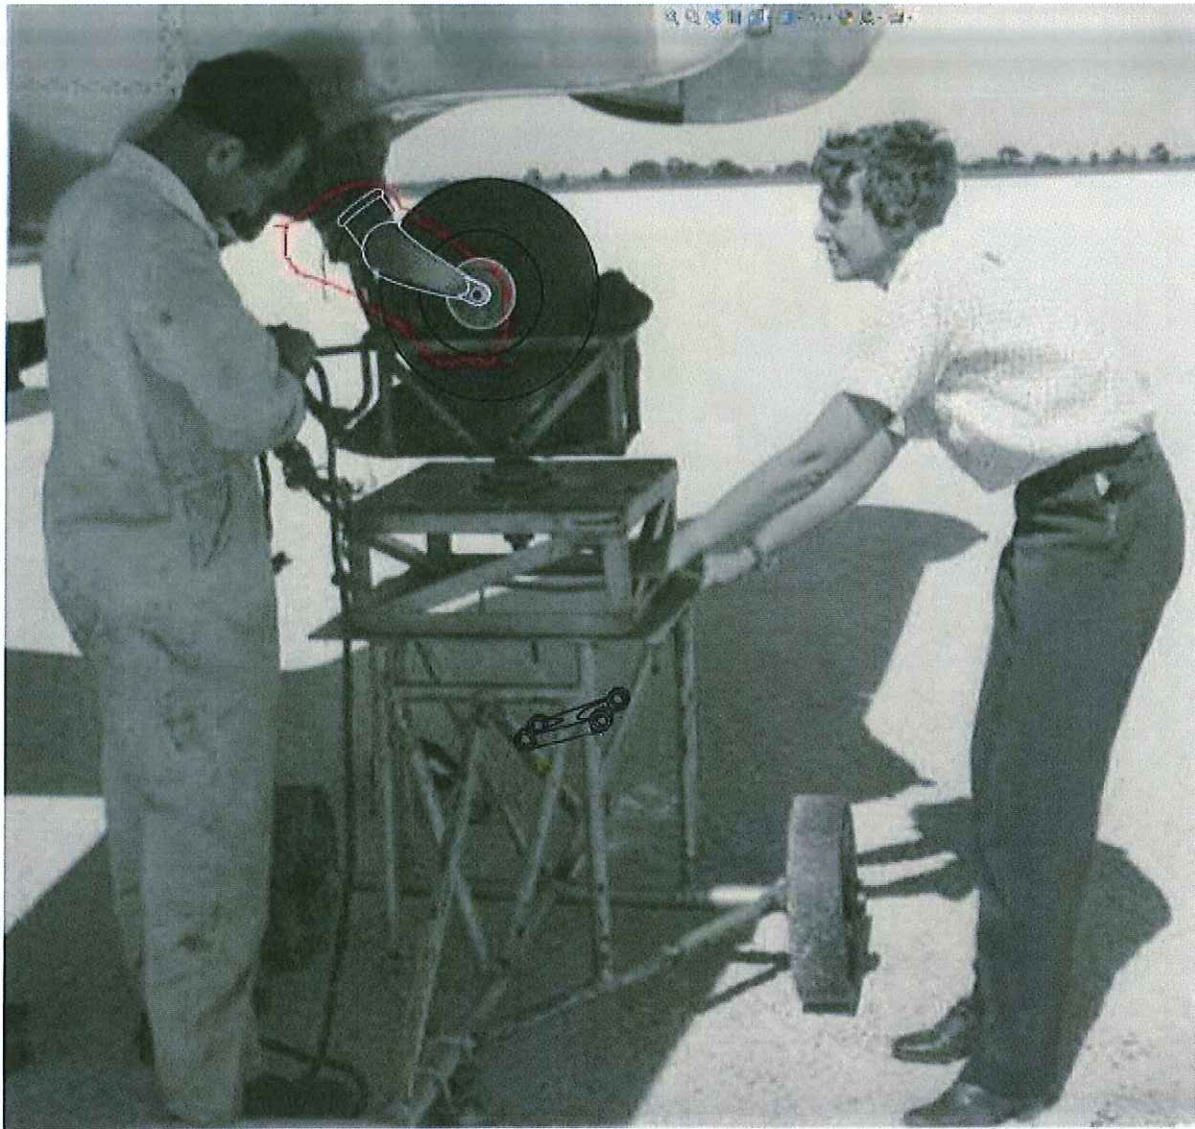
Figure 5: The rear landing gear with Amelia Earhart prior to her Miami departure.  
([http://tighar.org/Projects/Earhart/Archives/Research/Bulletins/05\\_Skullduggery/05\\_Skullduggery.html](http://tighar.org/Projects/Earhart/Archives/Research/Bulletins/05_Skullduggery/05_Skullduggery.html)).  
Photo from: <http://tighar.org/smf/index.php?topic=571.165>
